The CV10/CV15 are compact, cage-guided valves also known as a dump valves. They are ideally suited for a wide range of applications such as pressure control, level control and flow control. Typical installations include separators, scrubbers, wellheads and other production equipment. The CV10 is a close coupled design and the CV15 is an open yoke design.

## Model CV10/CV15 Installation

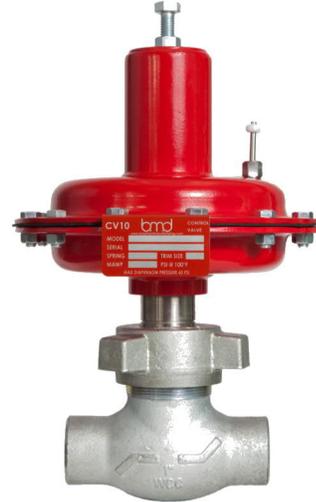
Figure 1.

## CV10 Reverse

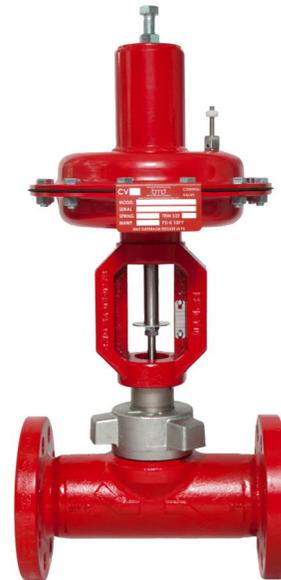
Figure 2.

## CV15 Reverse

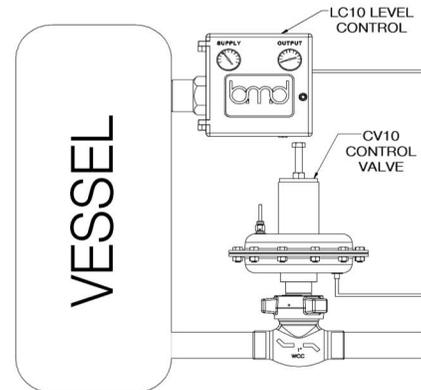
Figure 3. Typical Installation of CV10 w/ LC10 Level Controller

Before installing the CV10/CV15 make sure the threads aren't damaged and are clear of any debris on the vessel and valve. Install the CV10/CV15 according to your needs (Flow under seat, flow over seat). Thread in a 1/4" NPT fitting into the actuator (Upper housing for direct, lower housing for reverse). Connect an instrument that provides a pneumatic signal to the CV10/CV15.

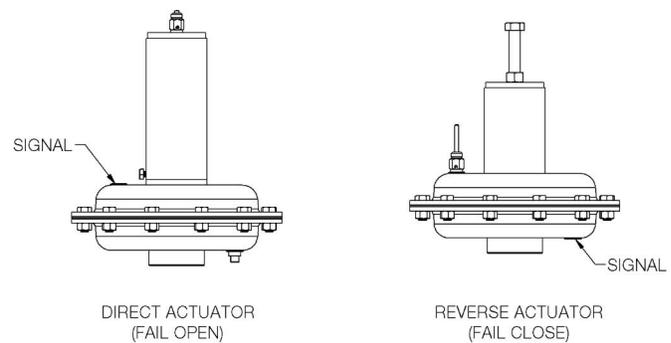
Figure 4.

When connecting a pneumatic signal it is important to understand the differences between a reverse and direct acting actuator. If it's reverse acting (fail close) the signal needs to be connected to the port in the lower housing. For a direct acting (fail open) the signal needs to be connected to the port in the upper housing. See figure 4.

The CV10 operates by receiving a pneumatic signal that, depending on the action of the actuator, will open or close the valve. For Reverse acting as shown in figure 4 the pneumatic signal enters in the lower housing. The pressure builds and overcomes the spring force allowing the plug to lift off the seat. For Direct acting as shown in figure 4 the pneumatic signal enters into the upper housing. The pressure builds and overcomes the spring force causing the plug to lower onto the seat.

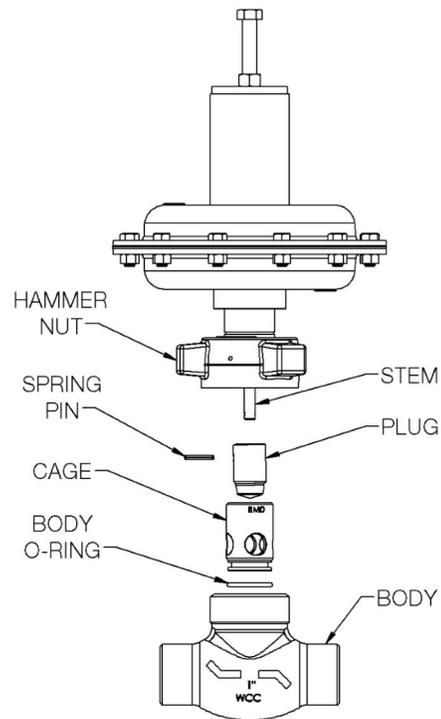
Figure 5.

Before changing the trim, make sure the CV10 is closed off from service. For a reverse acting actuator a pneumatic signal is needed to lift the plug off of the seat before removing the topworks from the body. Once air is supplied, break loose the hammer nut and remove the topworks. Use the cage removal tool to remove the cage from the body. Install the new cage and o-ring. Make sure the cage is pressed down and fully seated in the body. Remove the spring pin from the plug and unscrew the plug from the stem. The spring pin is best removed by using a small punch and hammer to drive it out. Insert the stem back through the packing plug and screw on the actuator. Screw on the new plug and install the new pin. Insert the topworks back onto the body and torque down the hammer nut. For a direct acting arrangement a pneumatic signal is not necessary and previous steps can be applied.

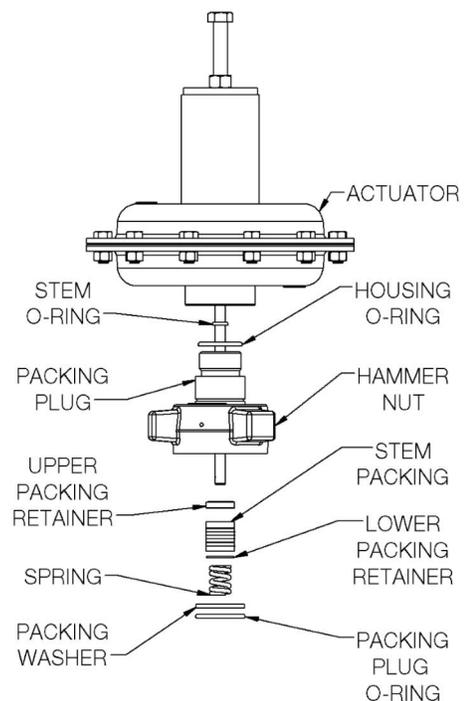
Figure 6.

Before replacing the packing, refer to the previous section and follow the instructions until the spring pin and plug are removed. Then, unscrew the actuator from the packing plug. Once the stem and actuator housing are removed from the packing plug, the packing can be removed. Remove the packing washer and spring. The packing itself can either be pushed out from the top of the packing plug or pulled out with a pick tool. Be careful not to scratch the bore of the packing as this can cause the valve to leak. Inspect the stem for damage as well. Any grooves or scratches on it can cause leakage through the packing. Before installing the new packing kit, put the packing plug back onto the stem and tighten the actuator onto the packing plug. Install the new packing, packing spring, and packing washer.

NOTE: BMD recommends greasing the packing set well with a PTFE based grease to enhance service life.

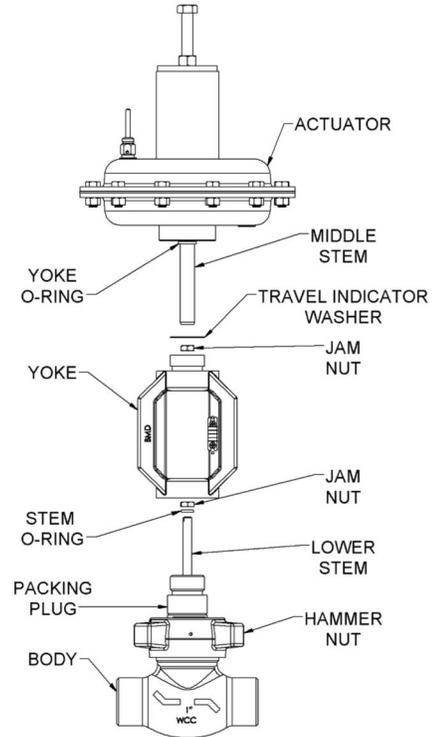
Figure 7.

In order to replace the diaphragm the topworks must first be removed from the valve, and the plug must be removed from the stem as described in the trim replacement section. For a reverse acting actuator loosen and remove the adjusting screw. For a direct acting actuator remove the spring cover, and loosen the hex nut that is on top of the upper spring retainer. Unscrew and remove all the bolts holding the upper and lower housing together. While holding the hex nut below the diaphragm, remove the jam nut and hex nut above the diaphragm. (On a direct acting actuator the upper stem will be removed instead of the upper jam nut and hex nut.) Remove the lock washer, diaphragm o-ring, diaphragm plate, and diaphragm. Install a new diaphragm and diaphragm o-ring and reassemble the housing.
